Manhole Inspection Summary

Manhole # S37EE1023MH

Location Address: **514 CHESTNUT HILL AVE**

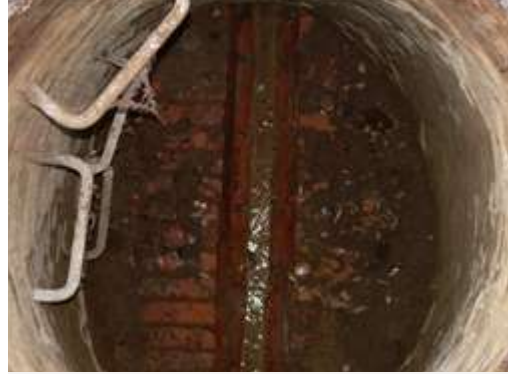
Top View

Evidence of surcharge - Bench debris.

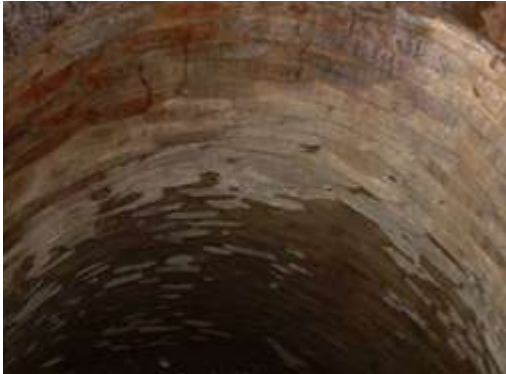
Defect

Frame leaks. Corbel and Barrel infiltration.

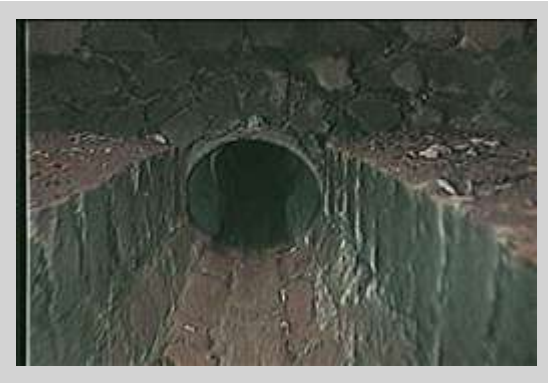
Pipe Out @ 12 O'Clock

Barrel deterioration and infiltration. Channel deterioration.

Infiltration: **None** Pipe Seal Cond: **Cracked**

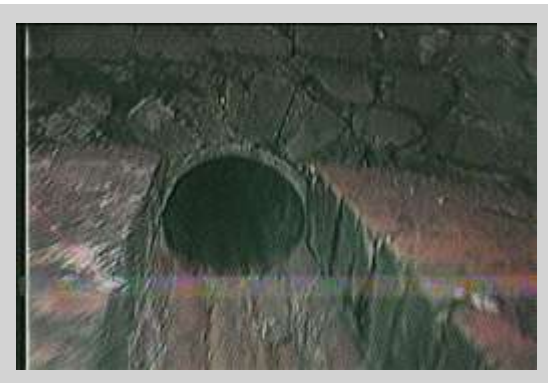
Pipe In @ 6 O'Clock

Barrel deterioration and infiltration. Channel deterioration.

Infiltration: **None** Pipe Seal Cond: **Cracked**
